TENDER DRAWING

CORNICE RESTORATION PROJECT

ALLEN SAPP GALLERY, NORTH BATTLEFORD, SK

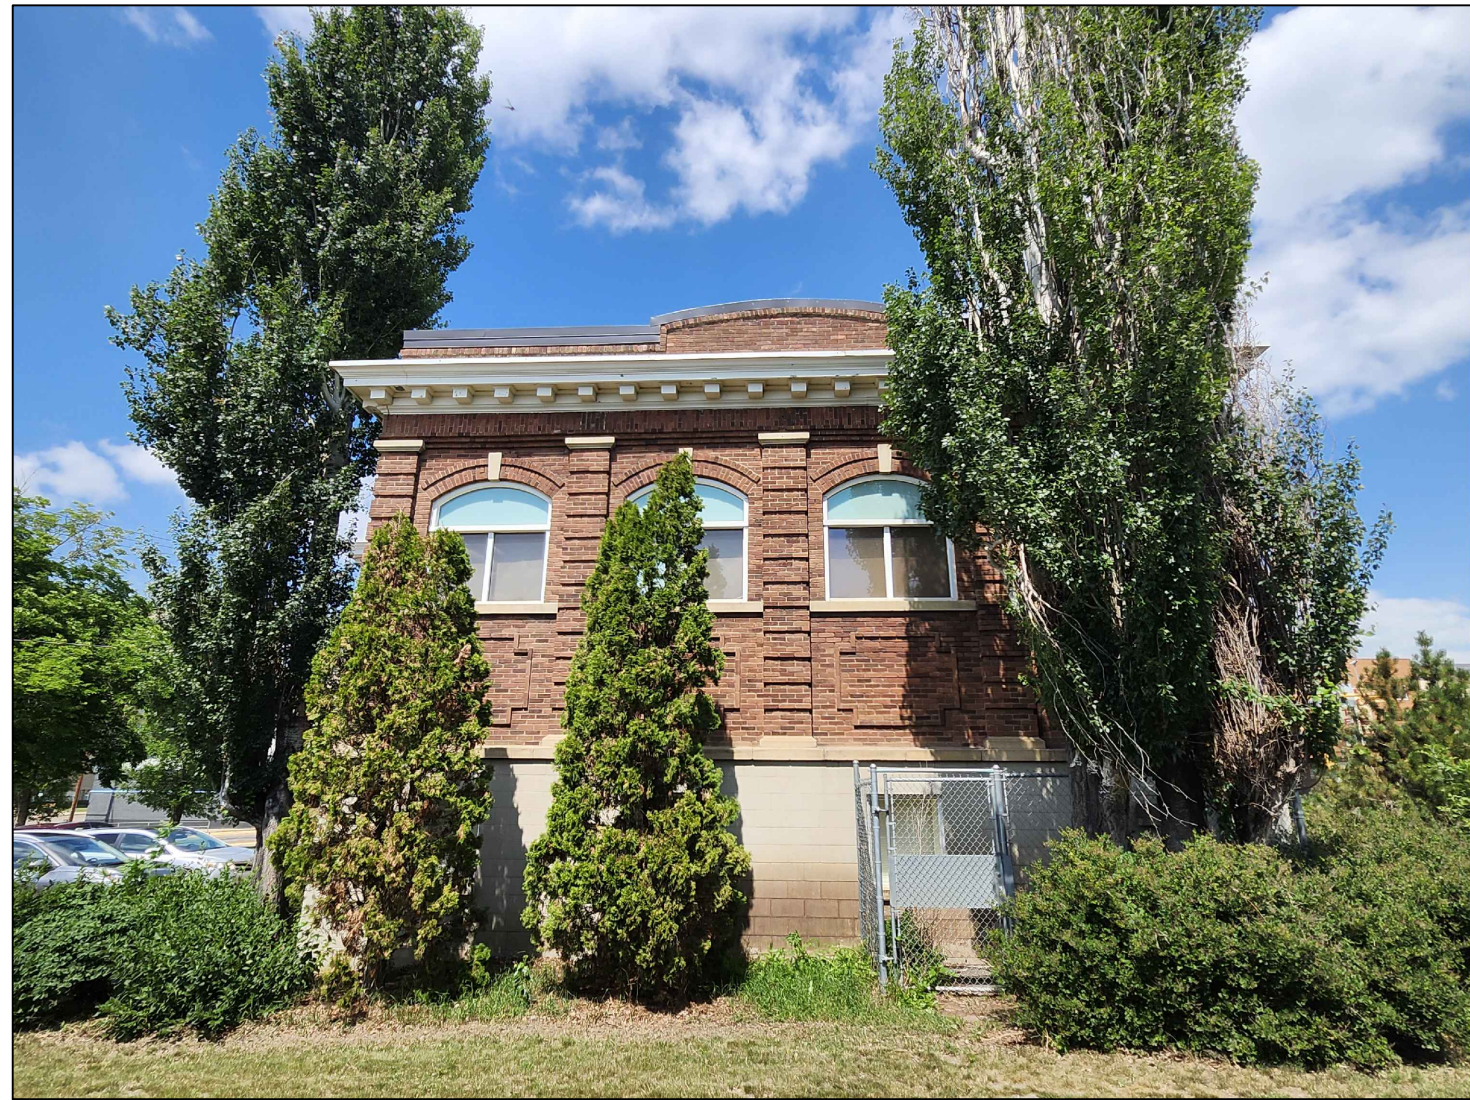
BUILDING SOUTH EXTERIOR

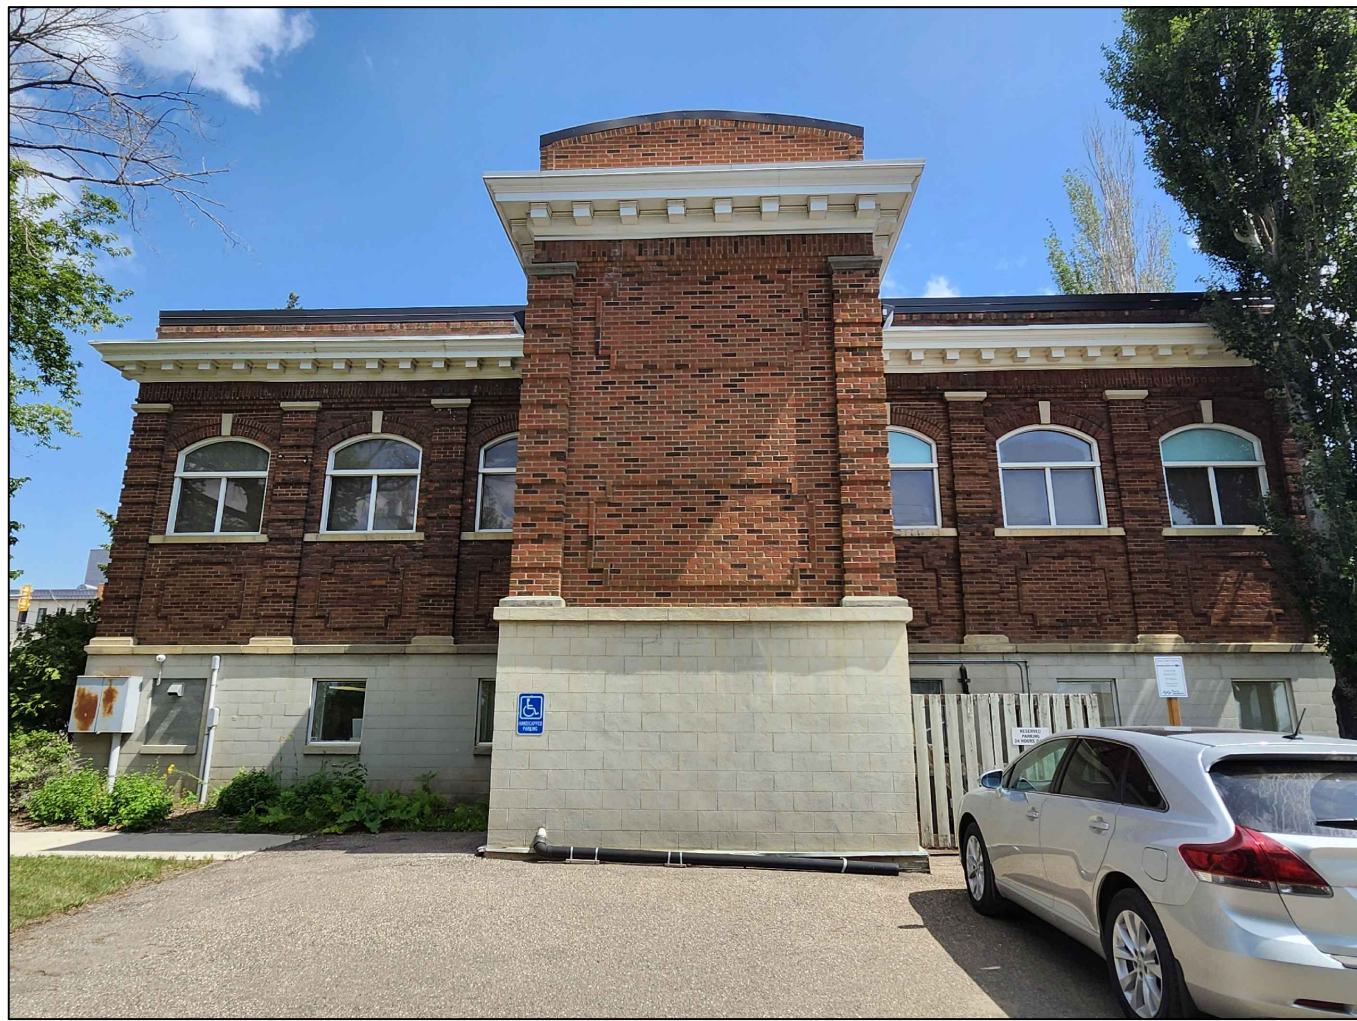
BUILDING WEST EXTERIOR - REAR ENTRANCE & ELEVATOR SHAFT

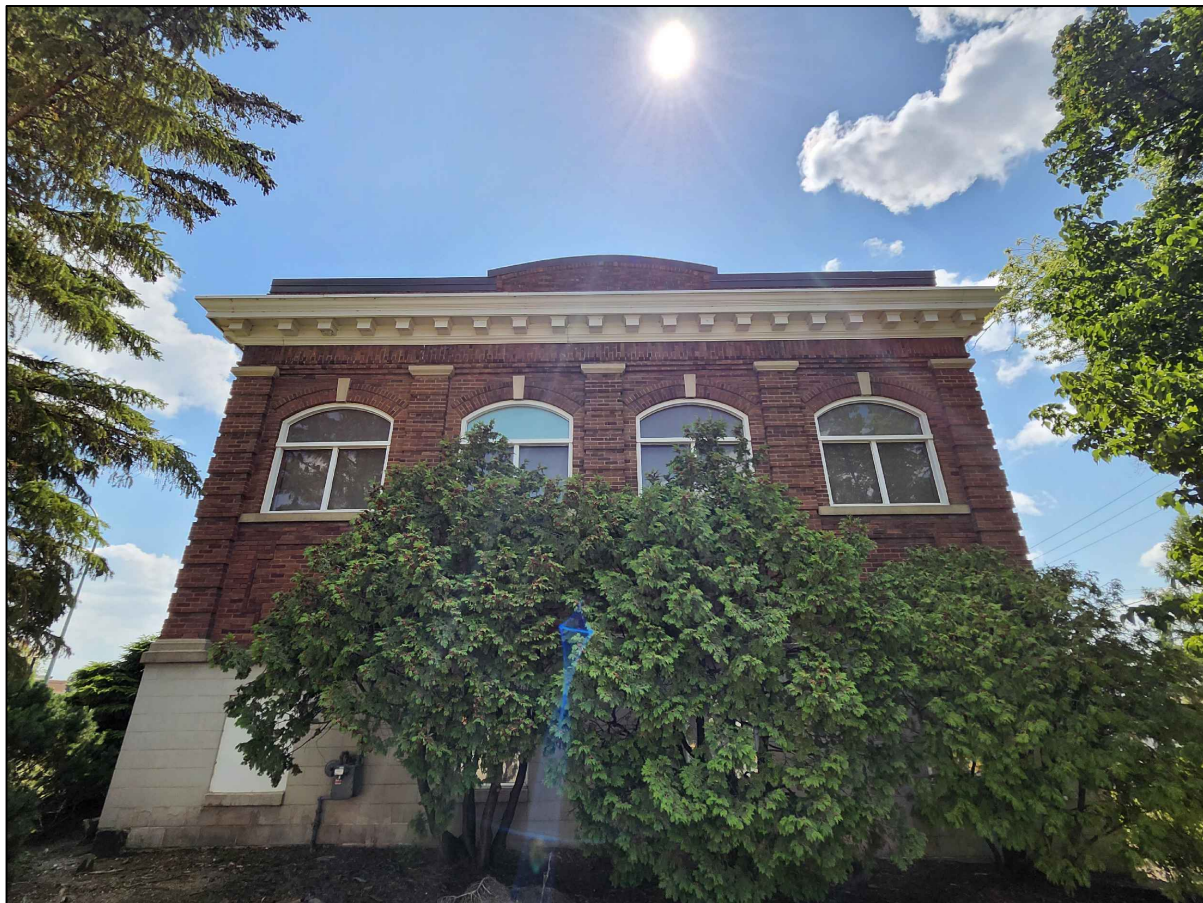
BUILDING NORTH EXTERIOR

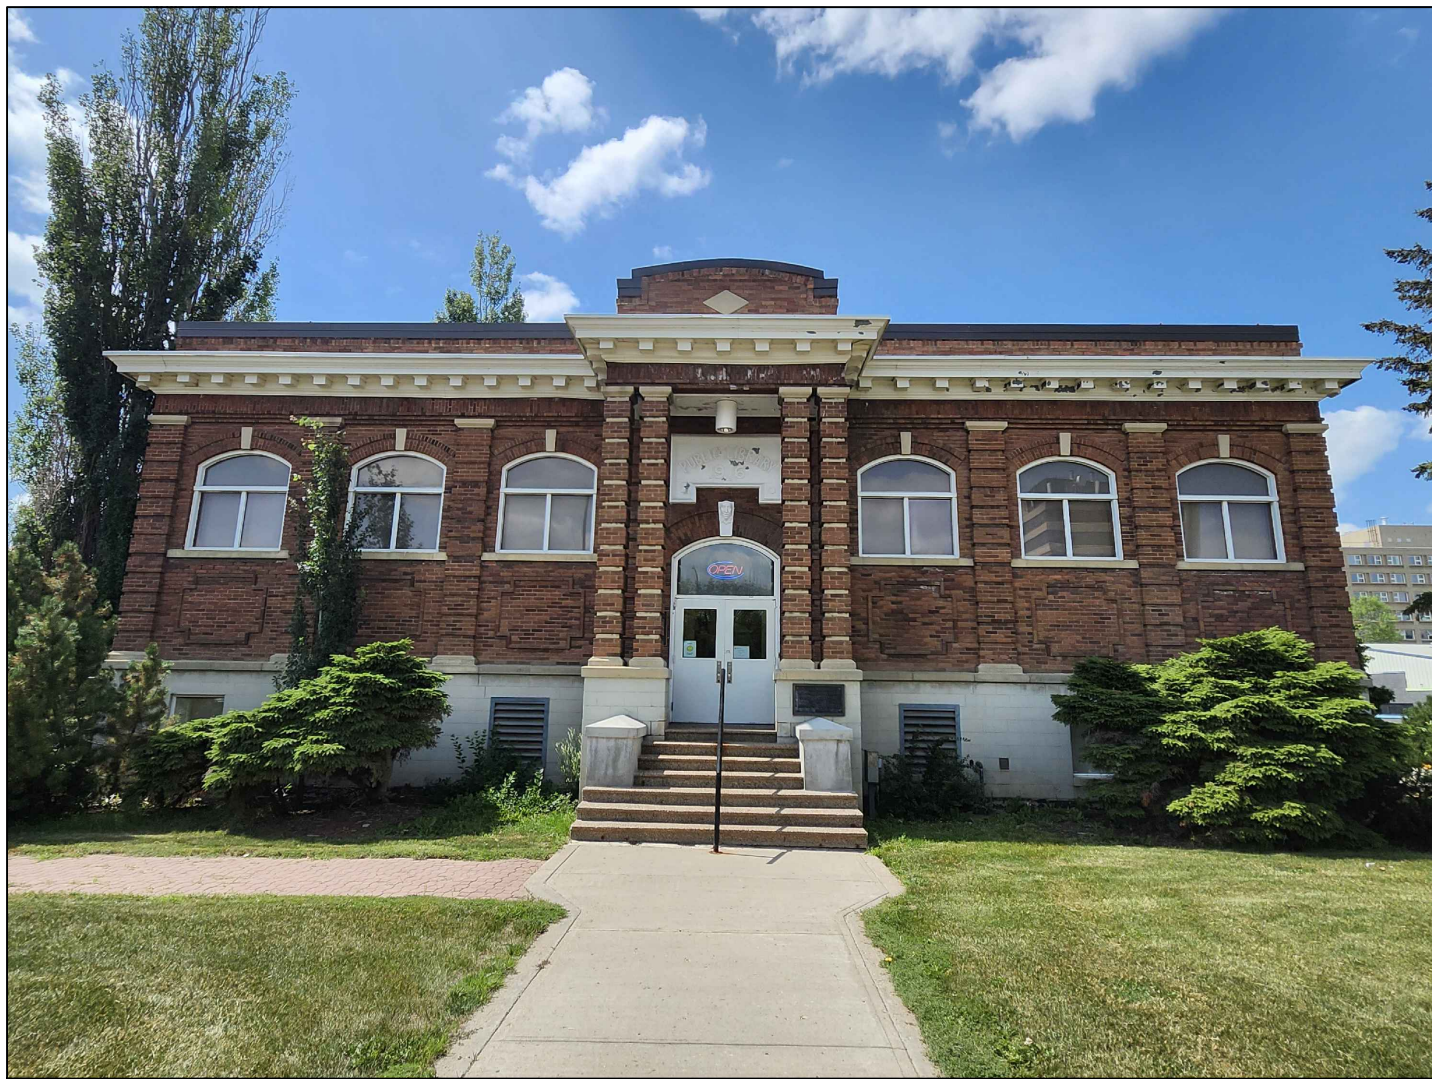
BUILDING EAST EXTERIOR - GALLERY MAIN ENTRANCE

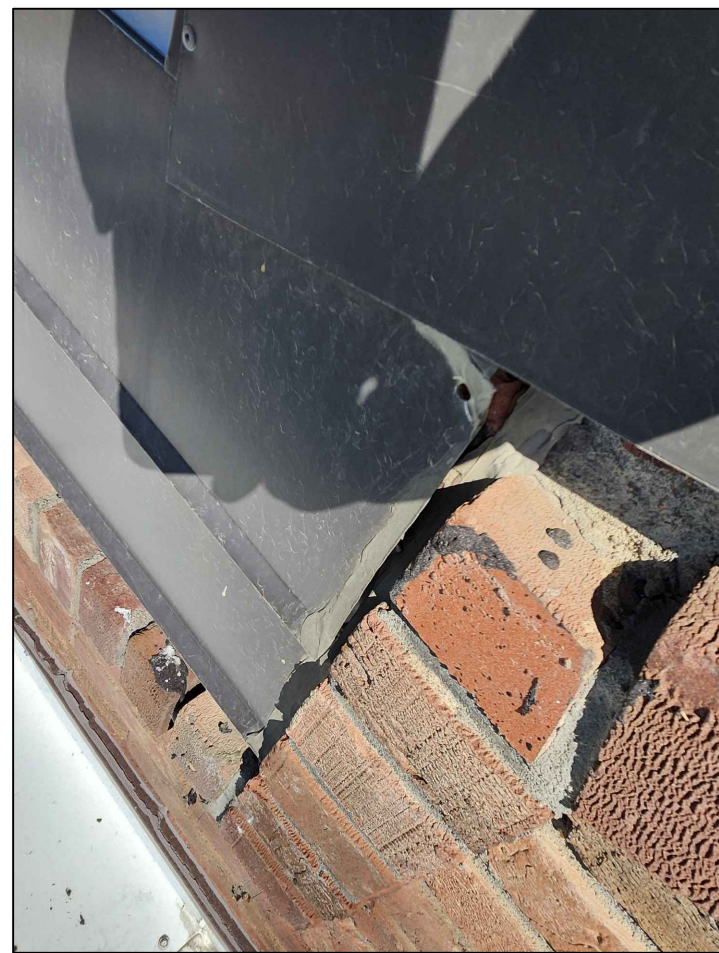
GAP AT VERTICAL PARAPET FLASHING

- SEALING OF GAPS BEYOND CORNICE
- ELIMINATE POSSIBLE ENTRY POINTS FOR MOISTURE, VERMIN AND INSECTS

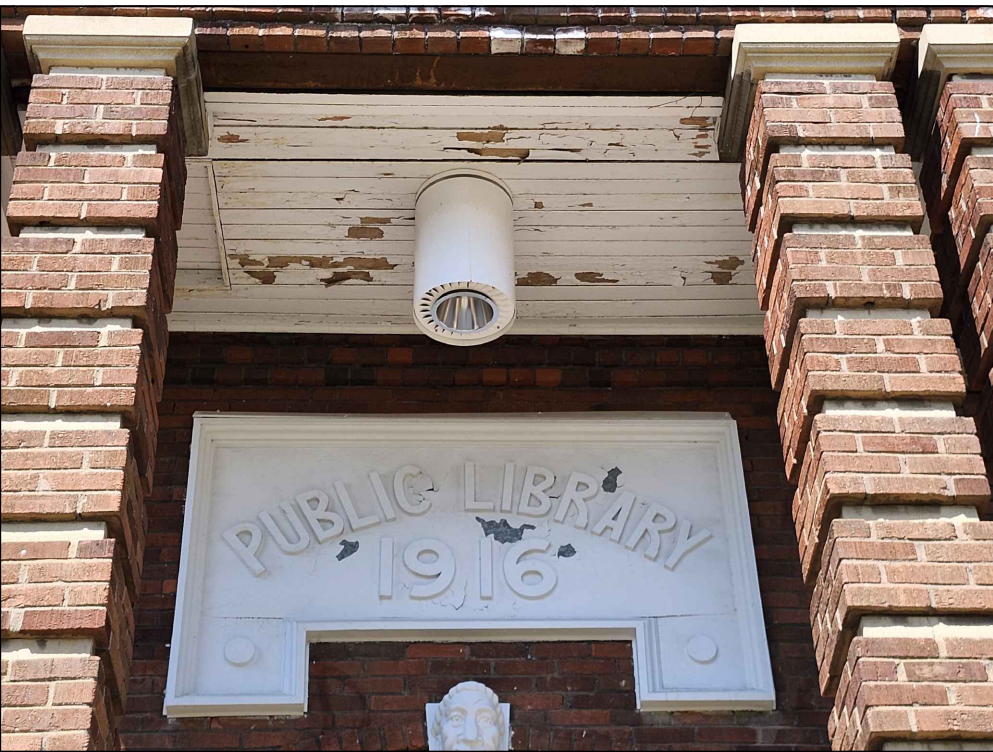
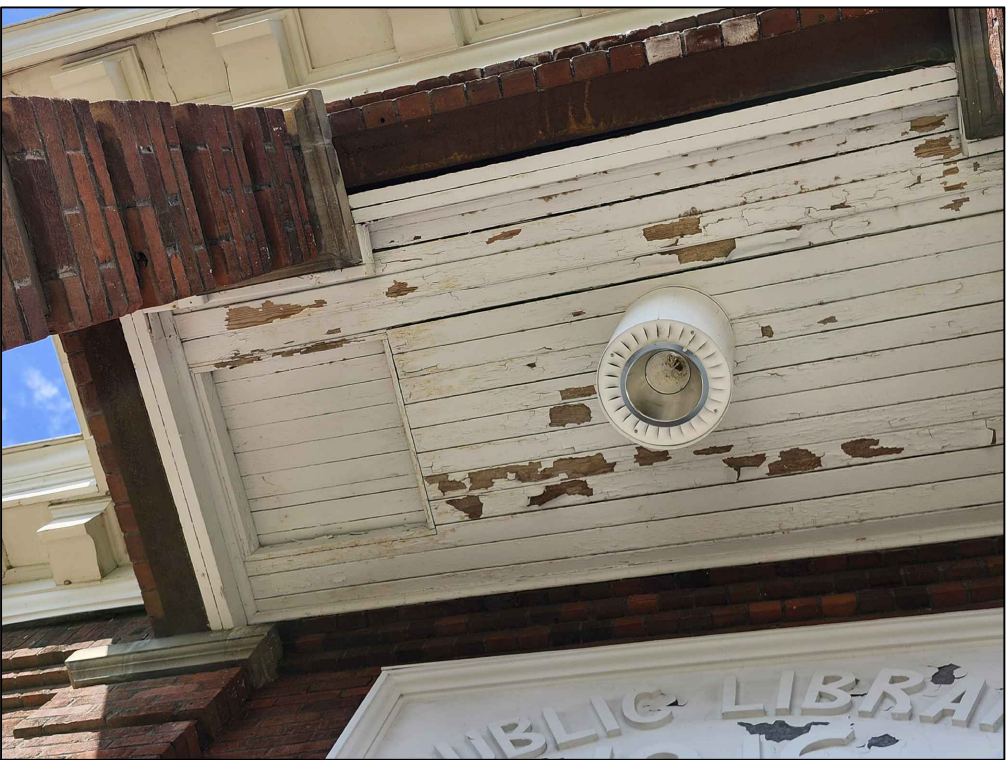
- REPAINTING OF WOODEN SOFFIT AT MAIN ENTRANCE VESTIBULE
- REPAINTING OF PUBLIC LIBRARY SIGN

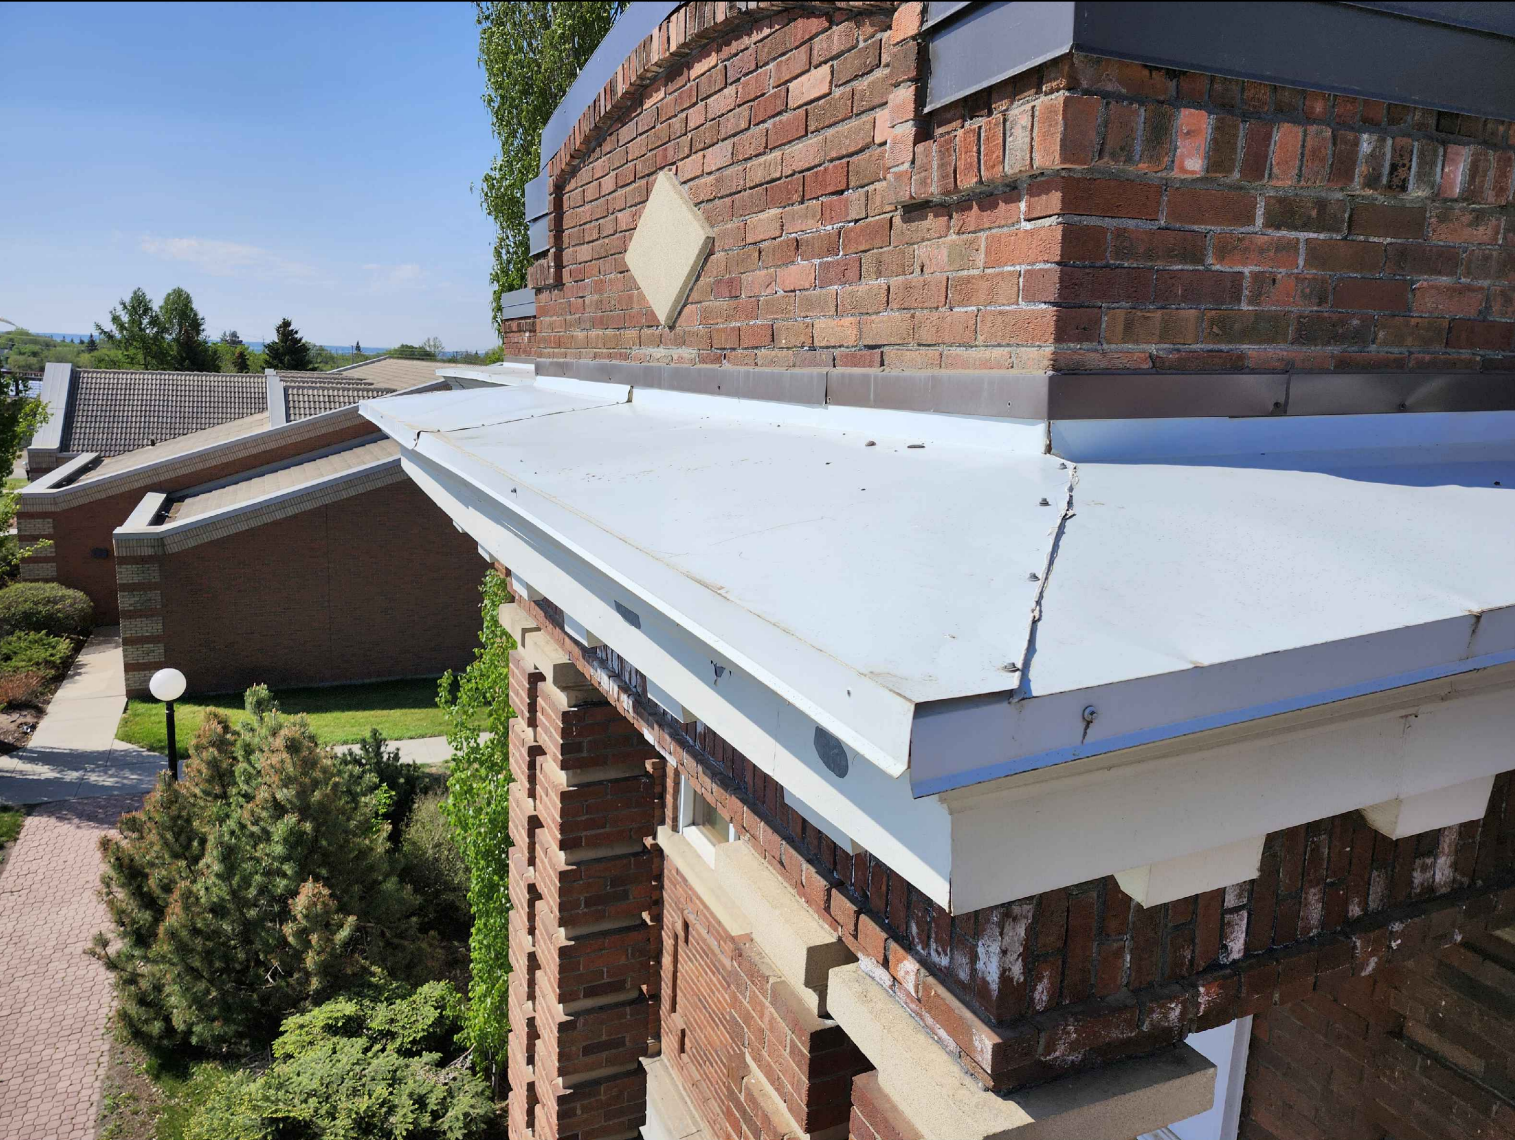
PROVISIONAL WORK 3: CORRECTION OF SAG AT MAIN ENTRANCE CORNICE

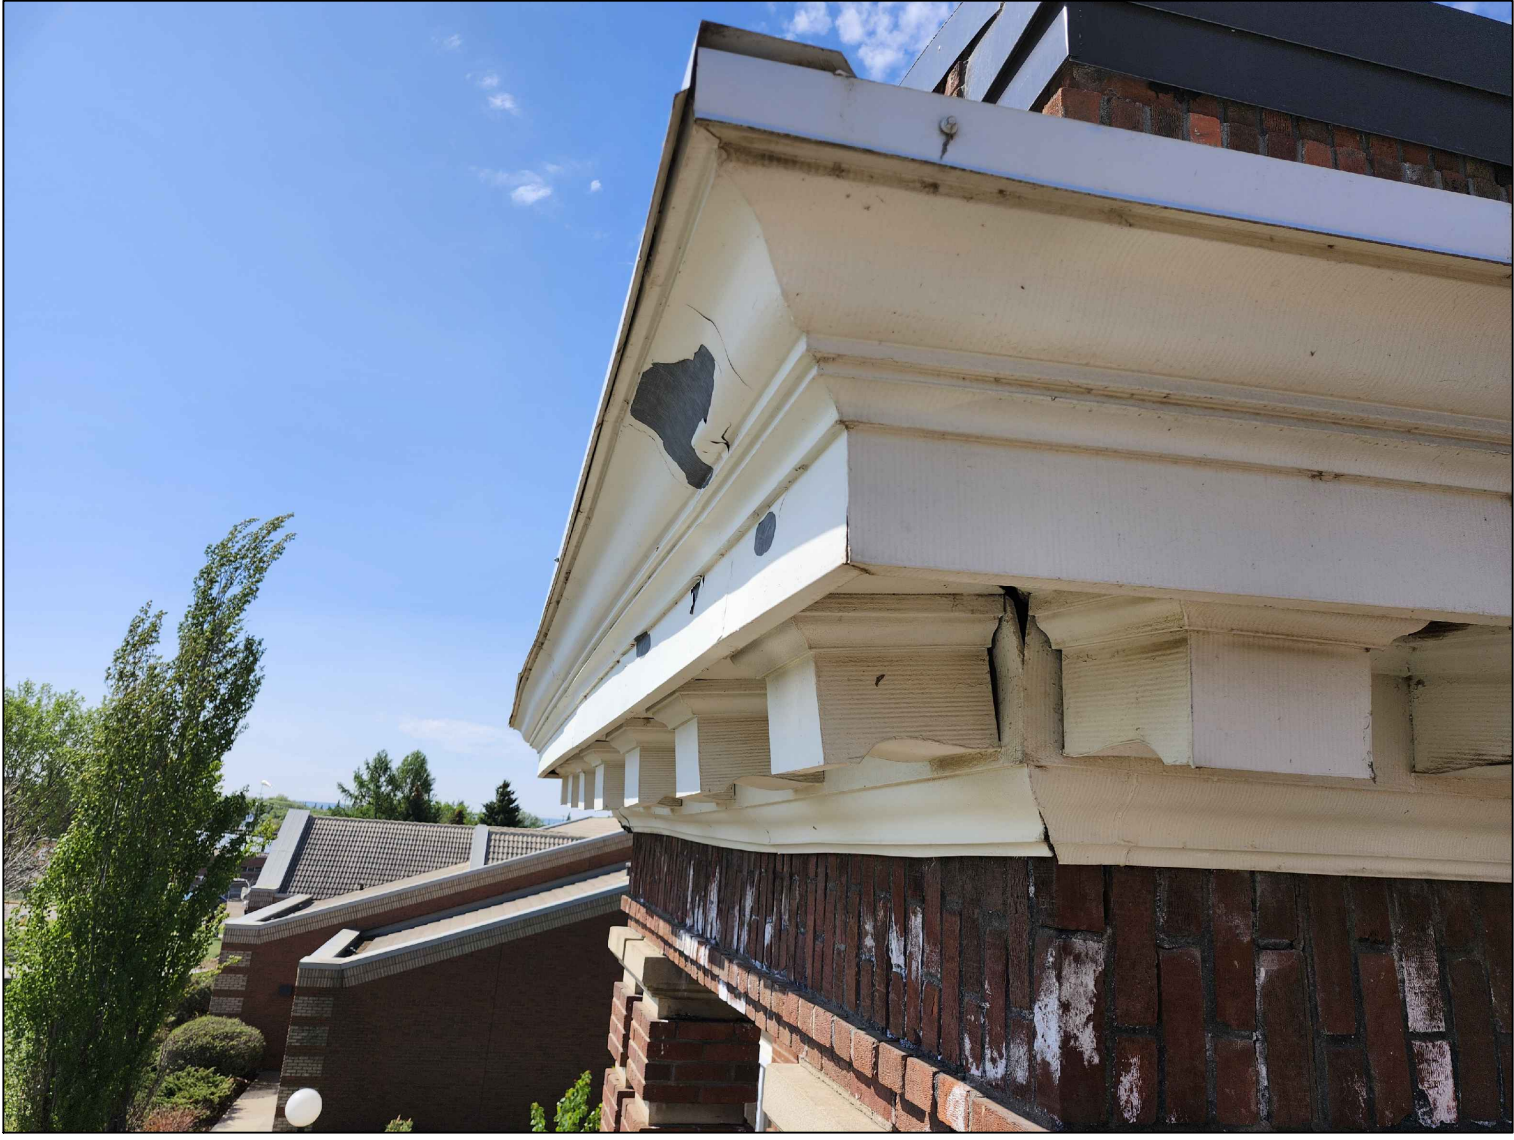
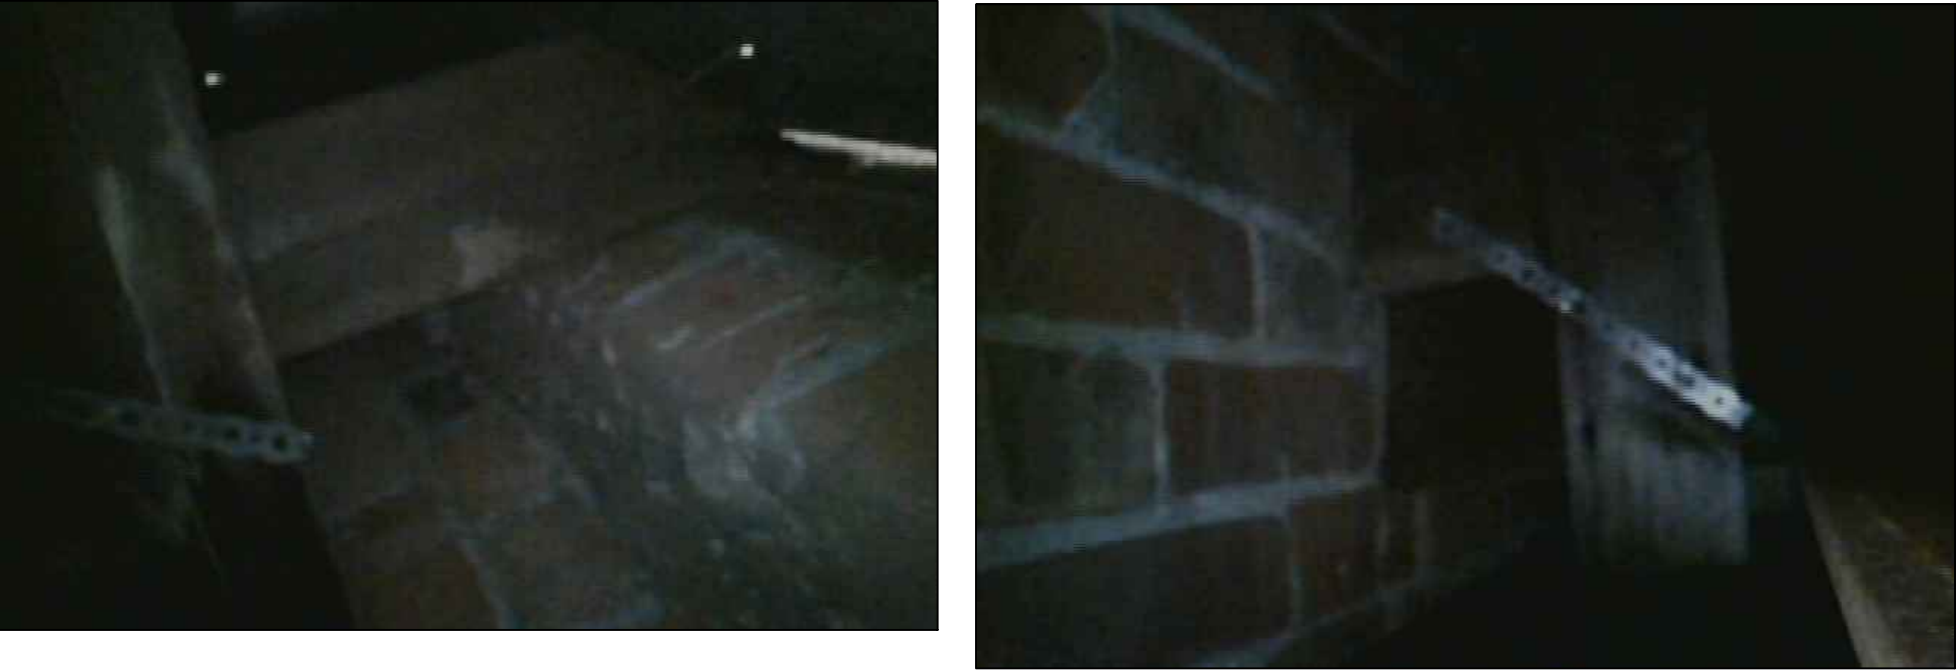
IMAGES CAPTURED BEHIND CORNICE USING PINHOLE CAMERA:

- Cornice wood frame appears to be supported by plumbers strap.
- Suspected reason for sagging is expansion & contraction of strap due to temperature fluctuations.
- Contractor is to propose method to eliminate sag and install a better method of support for the frame and cornice.
